We recently discovered the cause of a persistent high frequency vibration in the tail rotor drive system on our OH-58A. Other mechs may benefit by our experience.

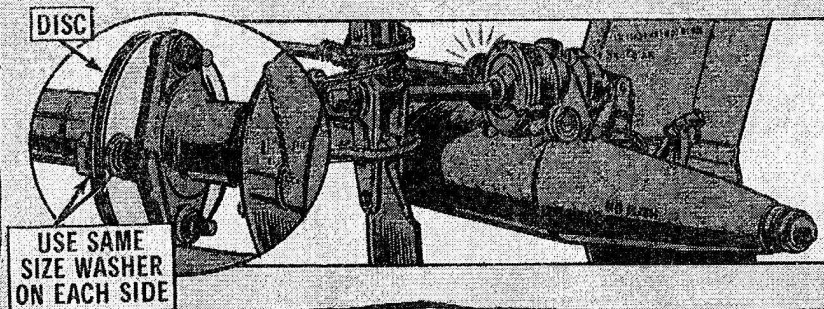
There're 2 different thicknesses of beveled washer, NSN 5310-00-131-2665, that are being used on the tail rotor drive shaft couplings.

When you install a washer of different thickness on each side of the disc, the drive shaft couplings are not able to slide back and forth freely. The disc flexes to compensate for this difference in washer thickness, causing the vibration.

To head off the problem, we simply use washers of the same thickness on each bolt.

(Ed Note: Right on! The washers are made from a primary and alternate steel stock with a tolerance of ± 0.006 inch. You are correctly compensating for the difference in size and weight.)
