RIGHT HANGER HOOK-UP?

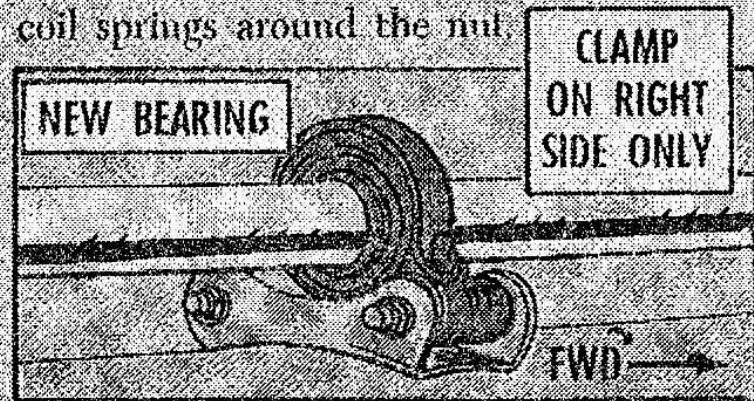
The new-model bearing hangers clamp on the right side of the shaft, facing forward.

You can spot the new hangers by the 3 coil springs around the nut.

Some recent OH-58's were made with the new hangers clamped on the left side. If you have one, change the clamp to the right side no later than the next Periodic inspection.

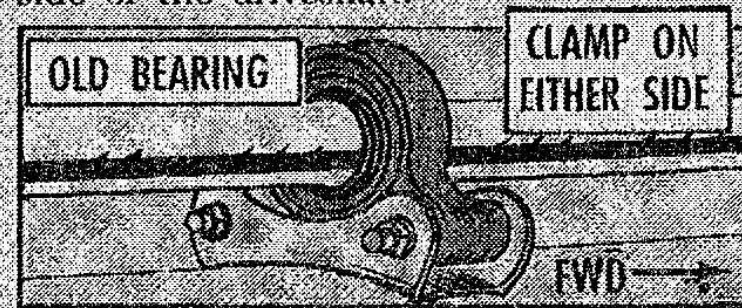
The old-model hangers clamp on either side of the driveshaft.

If a well-intentioned mech should get the new hangers on the wrong side, that driveshaft could be damaged.
