On the Level . . .

New Seal Needed!

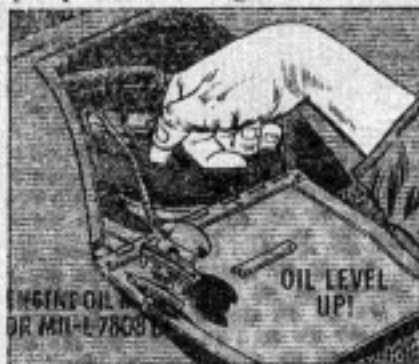
There's a seal, P/N 6854086, on the engine power takeoff shaft that is not doing the job. When it's shot, transmission oil leaks into the engine accessory gear case. From there it's pumped into the engine oil tank.

To solve the problem, in the area of the freewheeling unit, you need the new double lip seal, NSN 5330-00-185-0341, in place of the old single lip seal.
