ADDENDUM TO H-58-10-AMAM-11

COLLECTIVE FRICTION CLAMP

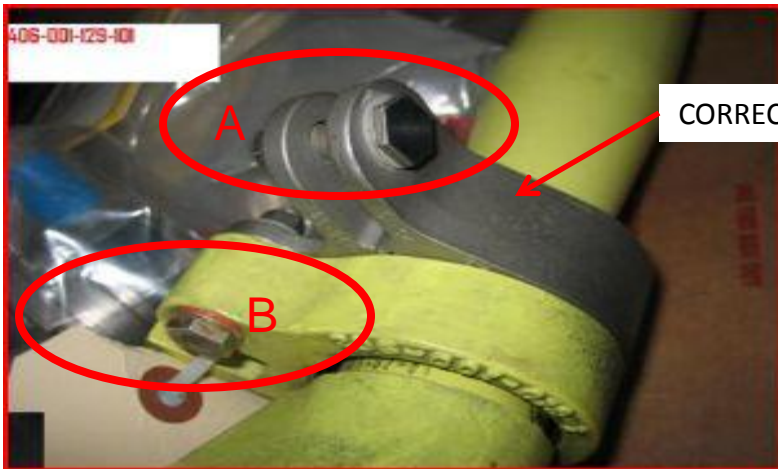
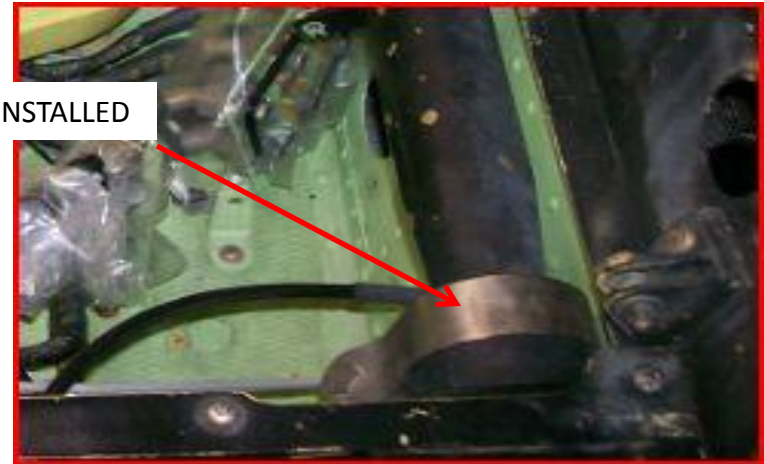
CORRECT PART INSTALLED

NOTE IN THE CORRECT PART THERE IS APPROXIMATELY 45 DEGREES BETWEEN THE "CLAMPING BOLT" (INSET A) AND THE "MOUNTING BOLT" (INSET B).

Note on the correct Clamp there is only about 45 degrees between the clamping bolt (inset A) and the mounting bolt (inset B).

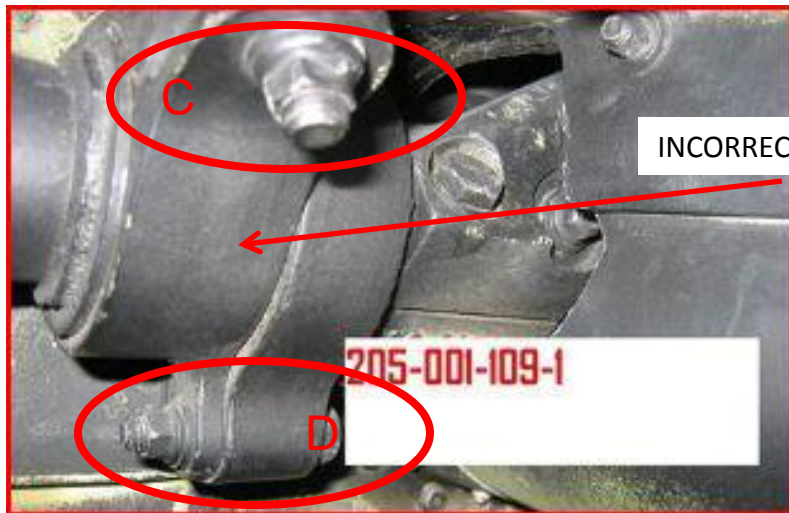
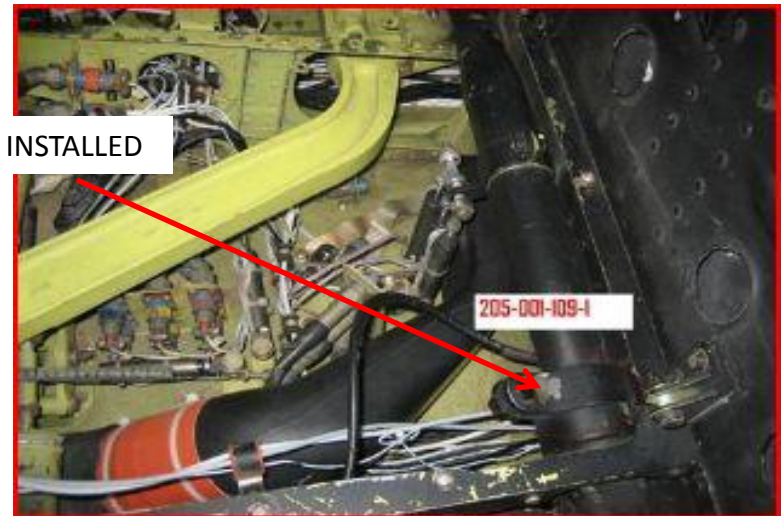
INCORRECT PART INSTALLED

NOTE ON THE INCORRECT PART THERE IS APPROXIMATELY 90+ DEGREES BETWEEN THE "CLAMPING BOLT" (INSET C) AND THE "MOUNTING BOLT" (INSET D).

On the old Clamp, there is approximately 90+ degrees between the clamping bolt (inset C) and the mounting bolt (inset D).
