TORQUE TUBE TALE

Dear Windy,
Fig 5-18, page 5-47, TM 55-1520-228-20 (Oct 72) gives damage limits for the torque tube assembly.

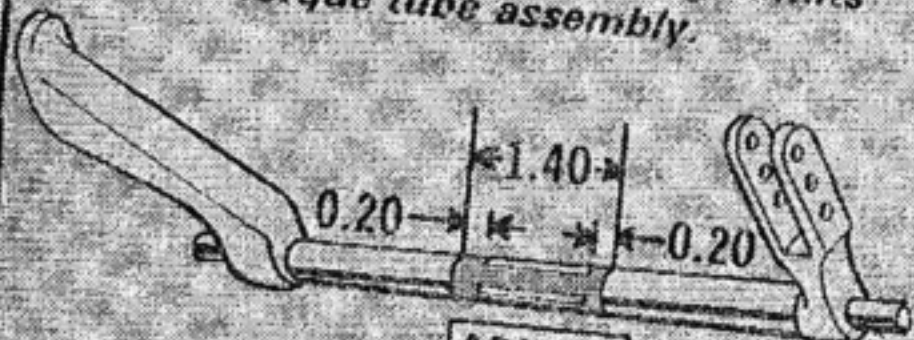
AREA A

Area A in this figure is to be FREE of dents. Does this mean we should replace the tube assembly for any damage to that area, no matter how small?

It sure does. NO rework is allowed in this area. Any visible twisting or denting of the slotted portion of the tube means that it's been subjected to excessive loads and should be replaced.
