Never flex the OH-58A main rotor blade by grabbing the tip cap, Kiowa mechs. That kind of treatment will crack the facing compound.

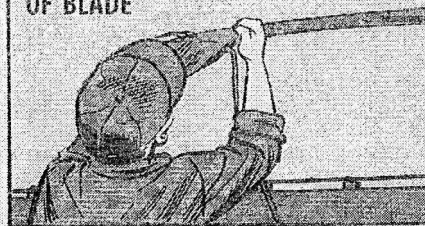
PUT BLADE TIE-DOWN OVER END OF BLADE

You won't be faced with a grounded bird, tho, if you simply insert the blade tie-down over the end of the blade.

Then, secure the blade. The tie-down will distribute the downward forces so you won't put excess pressure on the cap.

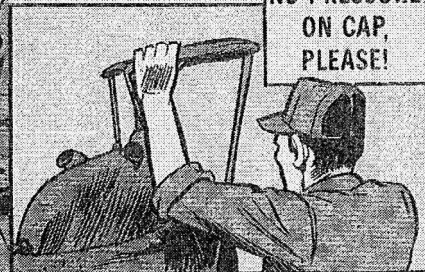
NO PRESSURE ON CAP, PLEASE!

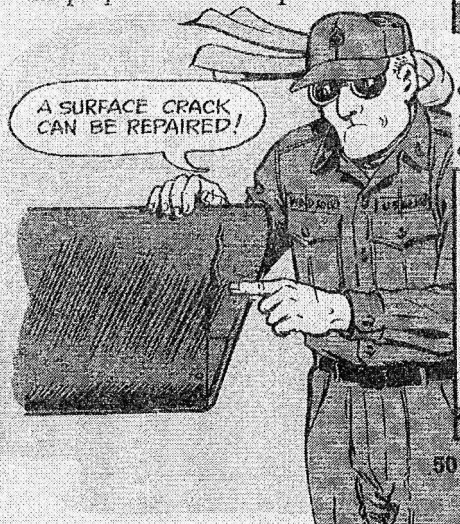
A surface crack in the compound—beginning about 4 inches aft of the spar and extending toward the trailing edge—is no cause for condemning the blade. There is no structural damage. Only the compound is affected so your buddies at support can make repairs in the prop and rotor shop.

A SURFACE CRACK CAN BE REPAIRED!
