Dear Editor,

TM 55-1520-228-20 (Oct 72), para 7-6, lists a leakage limit of 1 drop per minute (in a static condition) at the aft bearing cap of the free-wheeling unit on our Kiowa.

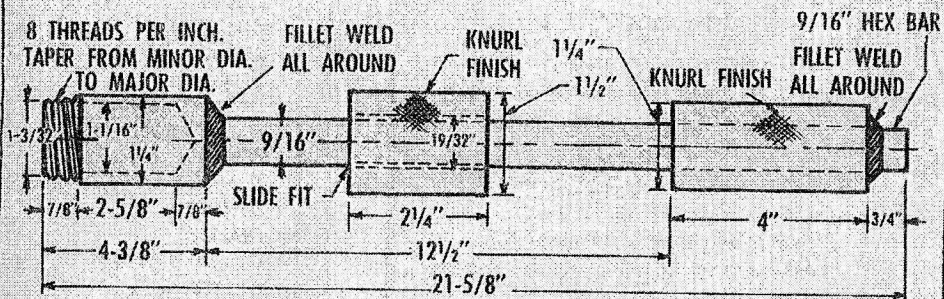
No more! Not with this handy impact puller we had made up in our shop.

NOTE: TOLERANCES NOT CRITICAL "AS ROLLED" FINISH EXCEPT AS INDICATED MTL: COLD ROLLED MILD CARBON STEEL (E.G. SAE 1020).

All we do is take off the first section of the tail rotor drive shaft. Then, we insert the puller and use the impact part of the puller to remove the seal . . . no sweat.
