Supplement to H-58-09-MIM-006
Approved Change to TM 1-1520-248-23 Requiring NDI of Tail Rotor Gearbox Support

DA Form 2028 DCN 09A01762, Web Reference Number 090430120

Make the following Changes to TM 1-1520-266-23

TAIL ROTOR GEARBOX SUPPORT ASSEMBLY (OH-58D) (ET).

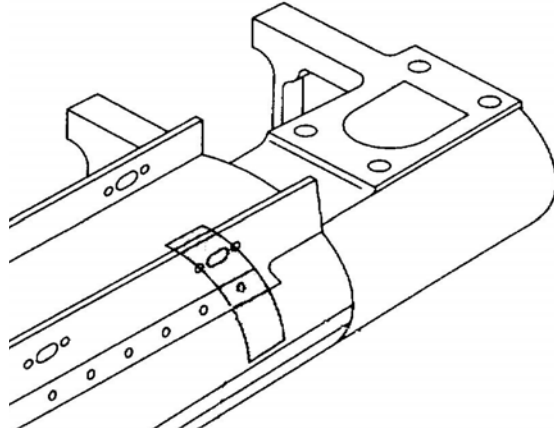
Figure 1. Tail Rotor Gearbox Support Area

4.9.2 Defects: Cracks may occur at various locations throughout the Tail Rotor Gearbox Support Structure, pay particular attention to the mounting holes and guide pin holes. No cracks are allowed.

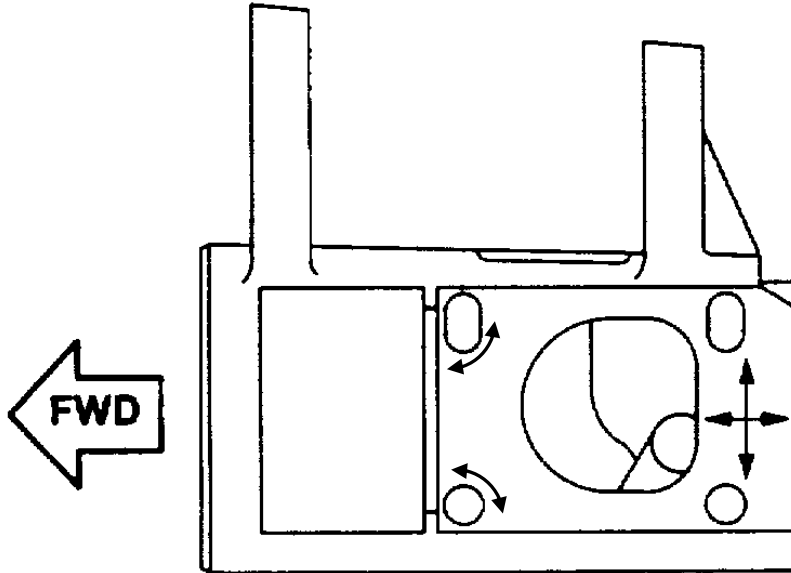
Figure 3

Pay particular attention around the holes. These areas are susceptible to cracking at the hole and propagating outward. (Refer to Figure 3)
