Driveshaft Cover Fix

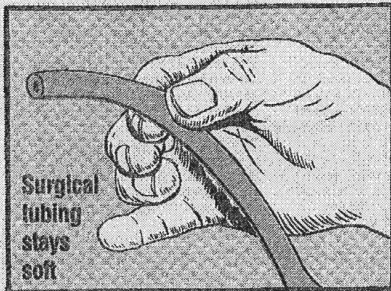
Surgical tubing stays soft

The rubber stays soft and won't wear into the tailboom skin like the nylon bushings do.

Replace the hard nylon bushings with pieces of 3/16-in ID rubber surgical tubing, NSN 4720-00-141-9080.

Use an art knife or razor blade to cut the tubing into 1½- to 2-in lengths. Slit the pieces lengthwise. Use adhesive, NSN 8030-00-753-4596, to glue them in place on the driveshaft cover.

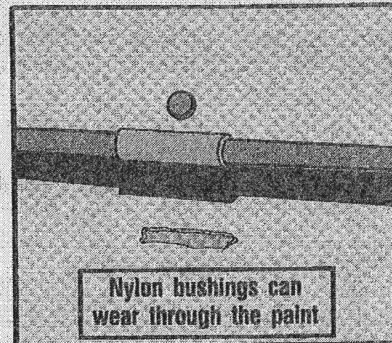
The nylon bushings that cushion the edge of your Kiowa's driveshaft cover can wear thru the paint on the tailboom's skin, creating a rust and corrosion problem.

Nylon bushings can wear through the paint
