# SAVE the PANEL!

Many of our OH-58A/C aircraft had to be repaired because the fuel filler cap was "dropped" during refueling. The cap, swinging on the long wire rope, hit the honeycomb panel with enough force to puncture it.

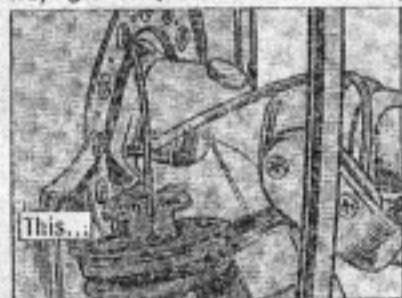
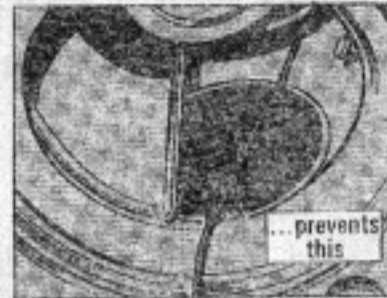
Relocating the wire rope also prevents foreign object damage caused by fraying of the plastic and metal during closed circuit refueling.

The fix can be used on other aircraft where damage to a panel or wire rope is a problem.
