OH-58 A/C...

## Prevent Flight Control Problems

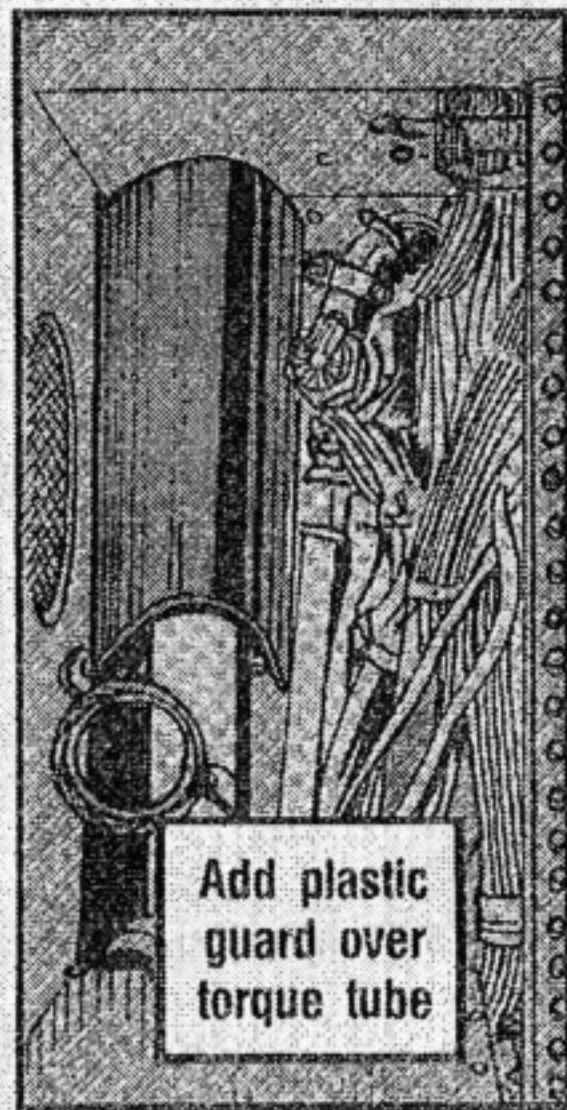
Here's the problem: the radio harness can rub against the tail rotor pedal torque tube, causing the tube to bind. And the last thing a Kiowa pilot needs is a binding tail rotor control.

So eyeball the radio harness. If it's too close to the tube, tie it out of the way. Use loop clamp, NSN 5340-01-050-1025. The instructions are in Para 14-29 of TM 55-1500-323-24.

If the clamp doesn't do the job, add a plastic guard over the torque tube. You need a sheet of plastic, NSN 9330-00-290-6493, and tape, NSN 7510-00-266-5016.

Cut a 5 1/2 x 9 1/2-in piece from the plastic sheet. Tape the edges. Slip the guard over the torque tube in the form of an arch. The weight of the harness keeps the guard in place.
