The Caution in Para 2-264 of TM 55-1520-228-23 (Aug 78) says that if the mount shims are lost, depot realignment is needed. Guessing at the shim count won't hack it!

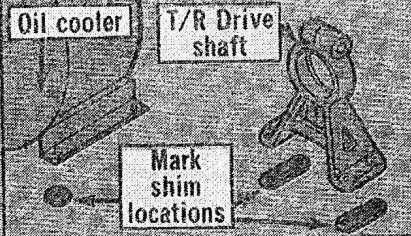
know the exact shim thickness, Para 6-139 in the Kiowa pub says depot level maintenance is needed for correct shaft alinement.

When you remove the oil cooler fan, or a drive shaft hanger that takes shims, mark the shim locations—every time!

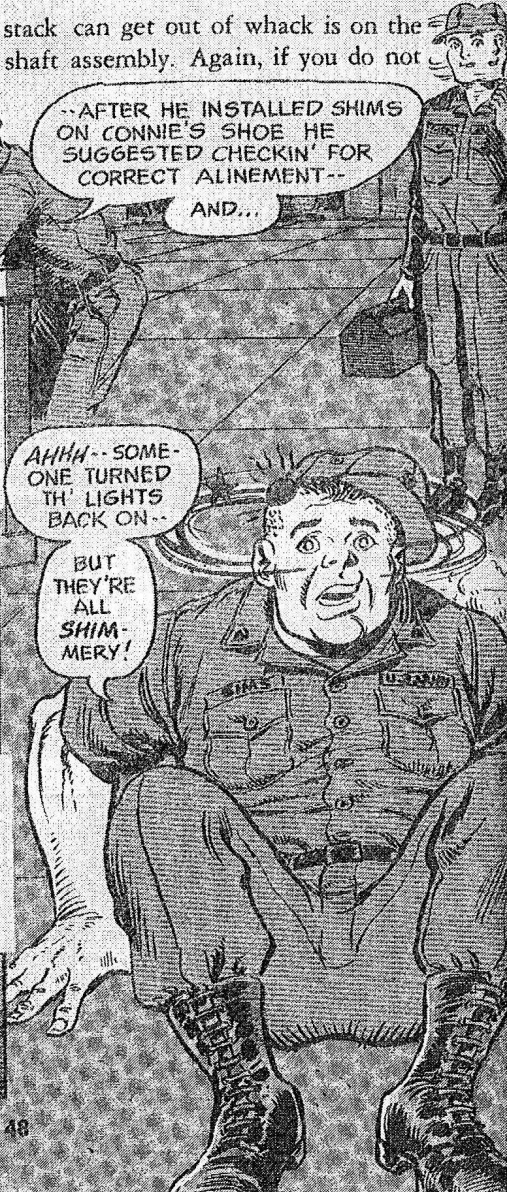
'Course, some shims are bonded to the airframe. When you remove a gear box from a Huey, for example, the shim stack probably won't get disturbed because it's bonded in place.

Shims bonded.. No problem!!
