# Enough's Enough

**S**ome Kiowa mechanics are still overfilling the tail rotor gearbox with lube oil and overgreasing the bearing inside the pitch control mechanism.

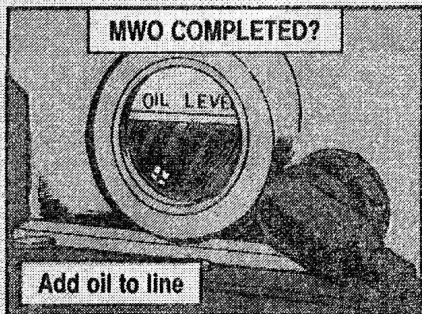
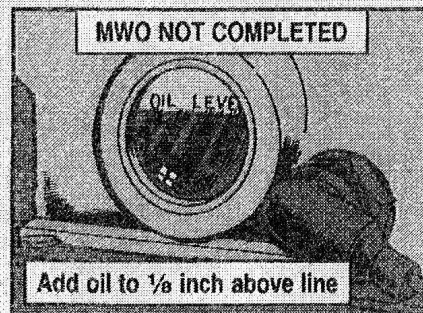
When you overfill the gearbox, excess oil runs down the output shaft during operation and gets into the trunnion and Teflon bearings.

So, when you add oil to the gearbox, allow a few seconds for the oil to stabilize before you read the sight glass. If MWO 55-1520-228-50-25 has

already been completed on your bird, add oil to the indicator line only. If the MWO has not been applied to your bird, add oil until it's 1/8 inch above the indicator line.
