Gearbox Contamination?

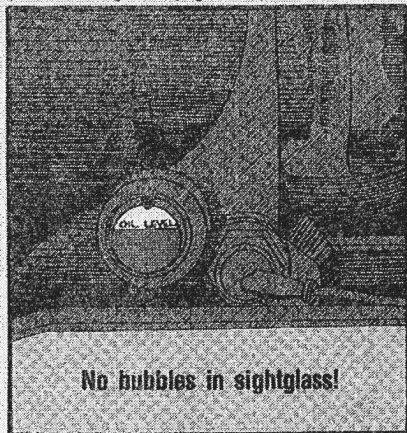
Moisture in the air contaminates oil. It gets through the filler cap or through seals. So always be on guard. Eyeball the sight glass during every pre-flight inspection.

If you see any water bubbles; or if the oil has a dirty, milky appearance, drain and flush the gearbox. Refill the gearbox like it says in your bird's maintenance manual.

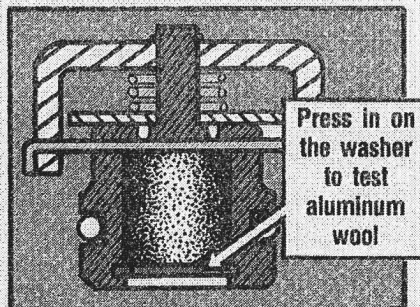
Another source of oil contamination is the aluminum wool that's part of the gearbox filler cap assembly.

If the AOAP lab says you have high aluminum wear in the gearbox, check out the filler cap.

Press in on the washer holding the wool in place, then release it. If the washer springs back against the retaining ring, the wool's OK. If it doesn't spring back, the wool is worn out.

Replace the wool with NSN 5350-00-286-4851. Use enough to put the washer under tension, then insert the retaining ring.
