OH-58 Main Rotor . . .

Thread Your Way Past Trunnion Damage

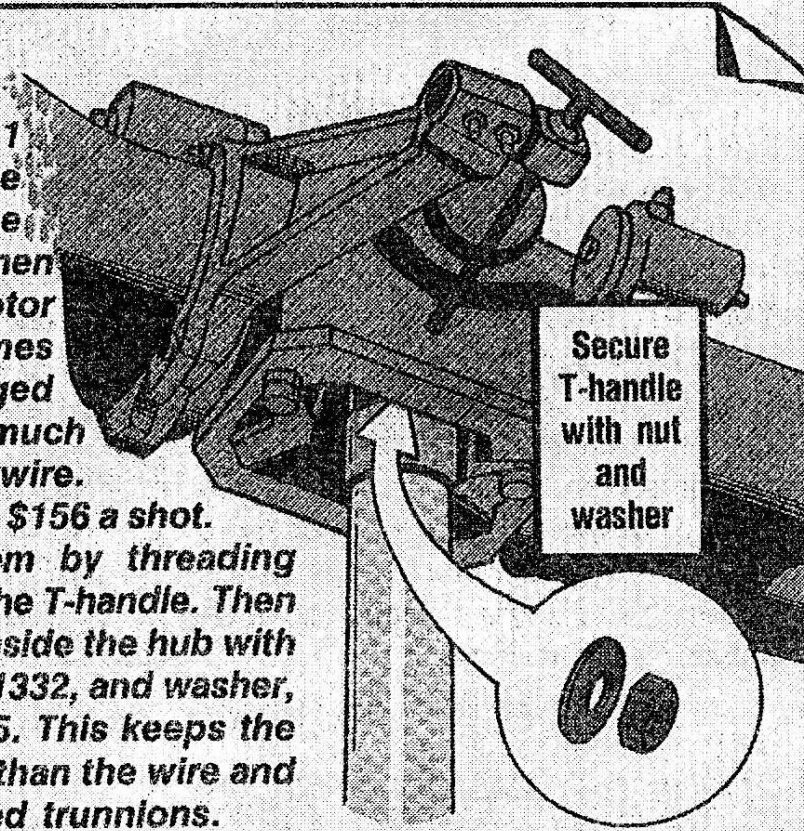
TM 55-1520-228-23-1 says to lockwire the T-handle work aid to the pitch horn trunnions when removing the main rotor assembly. But sometimes a trunnion gets damaged because it moves too much in spite of the lockwire. And the trunnion's cost \$156 a shot.

I avoid that problem by threading about one half inch of the T-handle. Then I secure the T-handle inside the hub with nut, NSN 5310-00-167-1332, and washer, NSN 5310-00-167-0835. This keeps the handle in place better than the wire and we get no more busted trunnions.
