Hollow Sound OK!

It won't work on the tip cap of your OH-58A/C main rotor blades, tho.

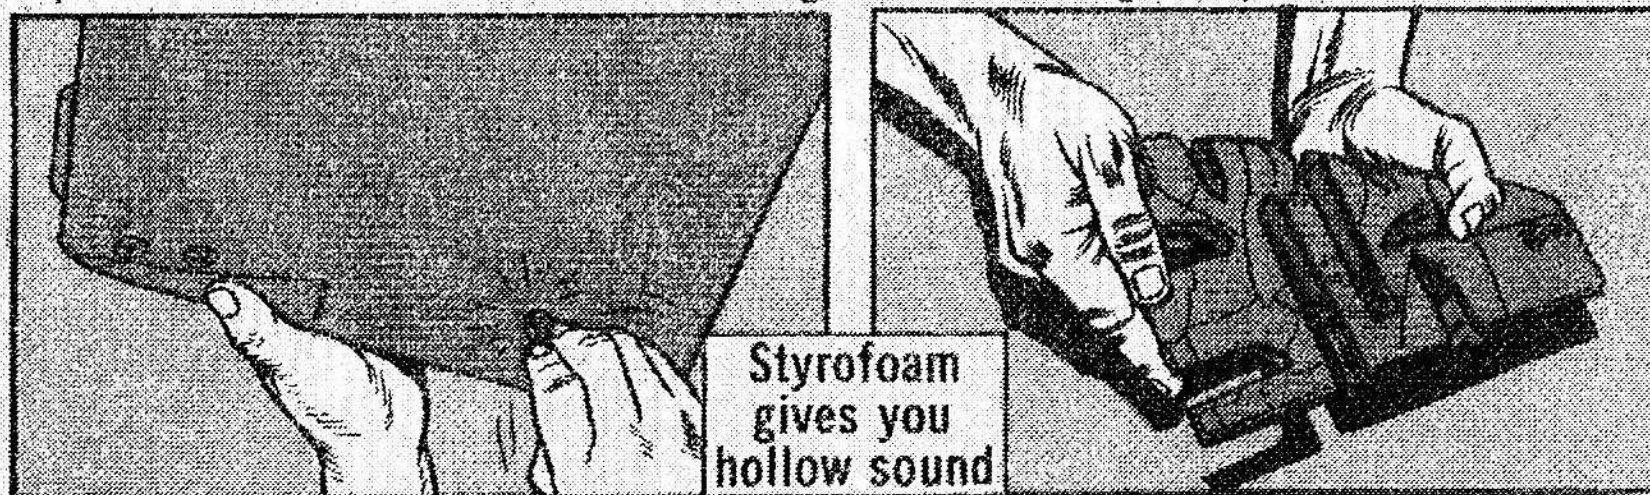
You always get a hollow sound when you tap the cap because it's filled with Styrofoam. You do not have a bonding void there requiring blade replacement.

Move inboard from the cap (Station 208, Fig 5-22 of TM 55-1520-228-23) and you'll get a solid response to your tapping.

So when you spot small dents in blade caps and flight characteristics are not affected, Para 5-86e (8) of the maintenance pub says you can keep 'em flying.
