OH-58 Kiowa...

Cast an Eye to the Mast

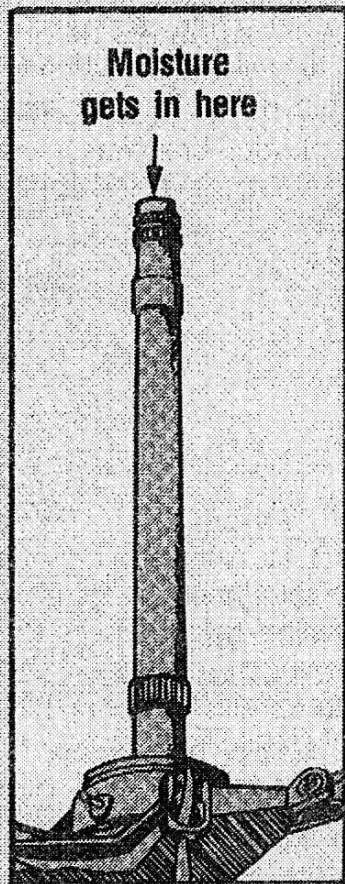
There's only one way moisture can get inside your bird's main rotor mast and do a corrosion number.

That's through the top of the mast when the protective cap's not sealed.

Some mechs forget to re-seal the cap when they remove it during the Phase Maintenance corrosion check.

Or maybe they think sealant's not necessary, that the cap'll keep moisture out by itself.

If you find corrosion inside the tubular steel shaft, you have to remove it and send it to AVIM for repair, just like it says in Para 6-93c of TM 55-1520-228-23.

If you don't find or suspect corrosion, no problem. Just be sure that you put a dab of sealant, NSN 8030-00-616-9191, around the lip of the cap before you re-install it.
