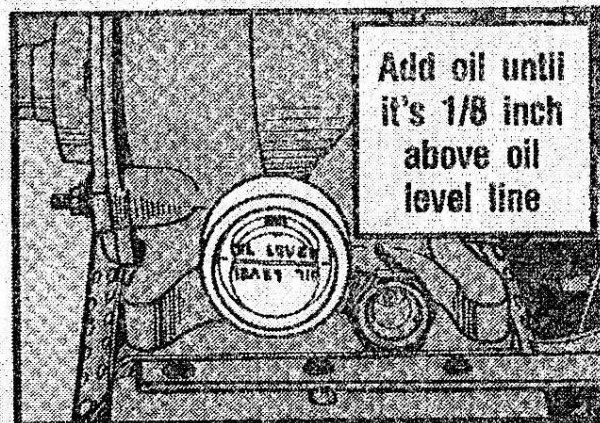
More is not better when it comes to lubricating the OH-58A/C tail rotor gearbox. Overfilling causes oil leakage. Then tail rotor trunnion bearings suffer. They wear faster and have to be replaced sooner.

That's 1/8 inch above the oil level line with standard gear. When high gear or floats are installed, the oil level should be even with the line.

So, Kiowa mechs, eyeball the gearbox sight gage. Add just the right amount of oil. Add a little at a time and let the level stabilize. Add a little more, if needed, to get the right indication on the sight glass.
