# Slip Solution

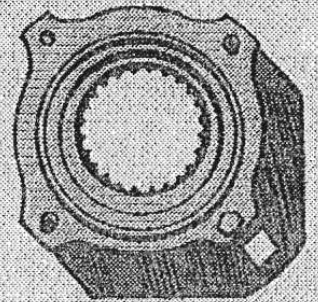
Removing and installing the OH-58 transmission main input pinion adapter gives you bruised knuckles, damaged honeycomb panels and component damage. Special tool T101555 slips off because of the 150-166 lb-ft torque on the nut.

Bolt tool to adapter

Just drill a 1/4-in hole in the special tool, using the adapter as a pattern.
