Tail Boom (Right Side) Cont.

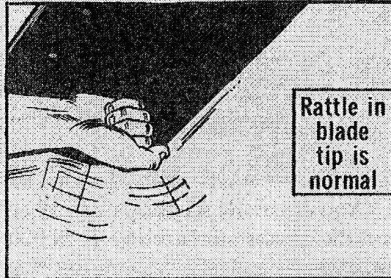
When you inspect the main rotor blades, a rattle in the blade tip is normal. The noise is caused by movement of the tip weights.

When the screws or weights at the inboard part of the blade are loose, tho, you have a different situation. The screws are bonded in place during manufacture. You're not allowed to tighten them, so Para 5-86g in the maintenance pub says the blade has to be replaced.

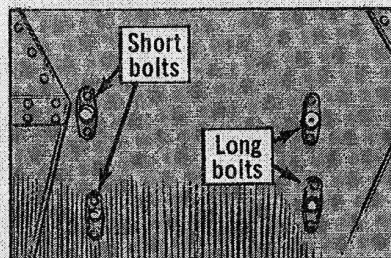
If your aircraft has the tail boom that has not been modified to use nuts and bolts for attachment of the vertical fin, only bolts and nut plates hold that baby. Two forward (long) bolts and 2 aft (short) bolts are used.

Have a look-see at the lower aft bolt because it could bottom out on the ballast weight, meaning the vertical fin is not secure. If that's the case, add

an additional thin washer next to the recess washer.

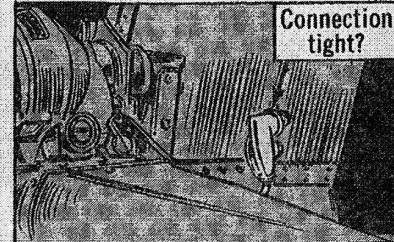
If the tail skid is extremely loose, the bird may have had a hard landing. Give the tail boom the once-over for skin wrinkling, which might indicate structural damage.

When you check the tail-rotor gear box, moisture in the sight glass—due to condensation—is OK. If the oil has a "milky" appearance, tho, call for a TI.

By the way, if the gear-box filler-cap spring doesn't give you a snug fit, spread it. If the spring is sprung, tho, change it.

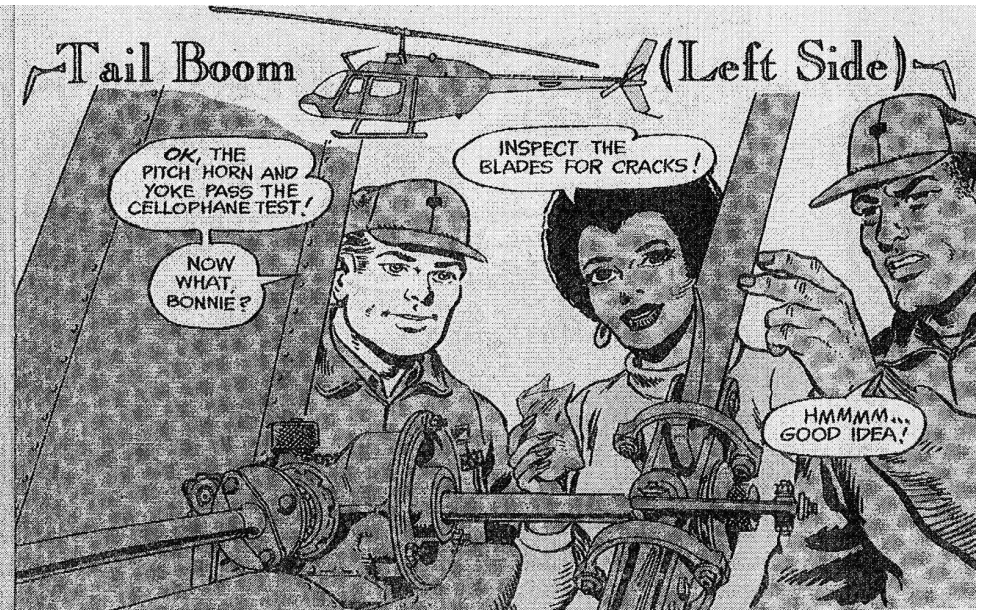
Tail Boom (Left Side)

You don't want metal-to-metal contact between the tail-rotor pitch horn and yoke, either. Take the cellophane from a pack of butts and insert one thickness between the 2 parts as your buddy gives you full left pedal. If the 0.001-in cellophane won't move freely, you don't have the 0.001-0.012-in required clearance.

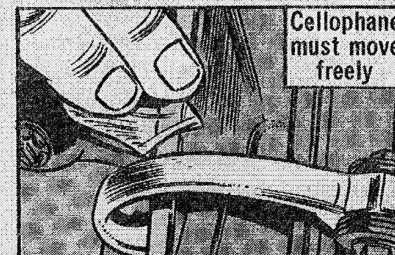
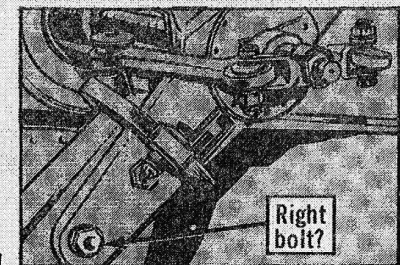
When you look at the tail-rotor blades, be sure you have the correct bolts at the outboard blades attachment points. The Caution in Para 5-188d of TM 55-1520-228-23 says only

NAS 1306-31 thru -36 bolts are authorized. The NAS 676 titanium bolts originally used won't hold up with the current self-locking nuts...the bolt threads go to pot!
