KEEPING YOUR ENGINE

COOL

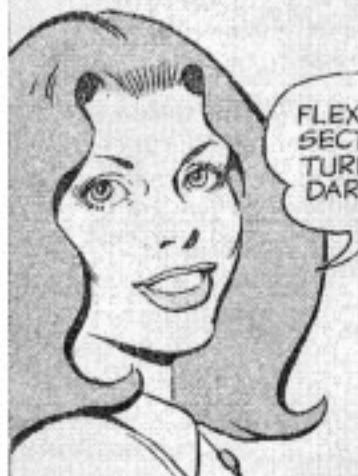
A bleed air leak is easy to spot, tho. The steel mesh will turn

dark from the heat. If it does, remove the tube assembly and blow through it. If air comes through the mesh, the tube is no good. Replace it.

FLEXIBLE
SECTION
TURNS
DARK!

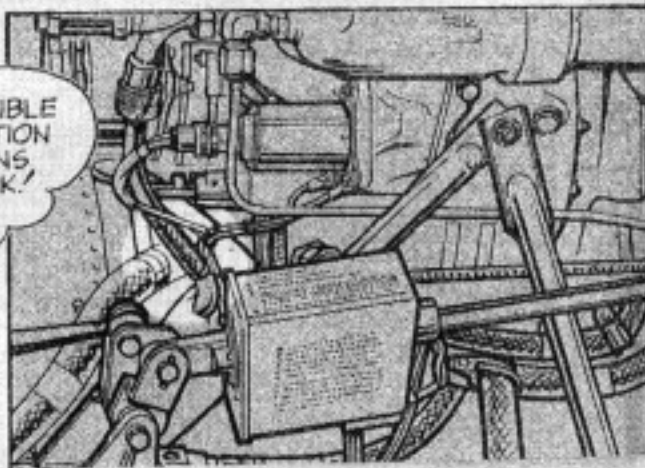
Course the tube channels hot air from the turbine to the cabin when the heater is on. When the tube goes bad, the air escapes continuously through the flexible portion of the assembly, if the heater is on or off.

If you need to refresh your memory, Kiowa mechs, the tube is item 25 in Fig 51 of TM 55-1520-228-23P (May 76).
