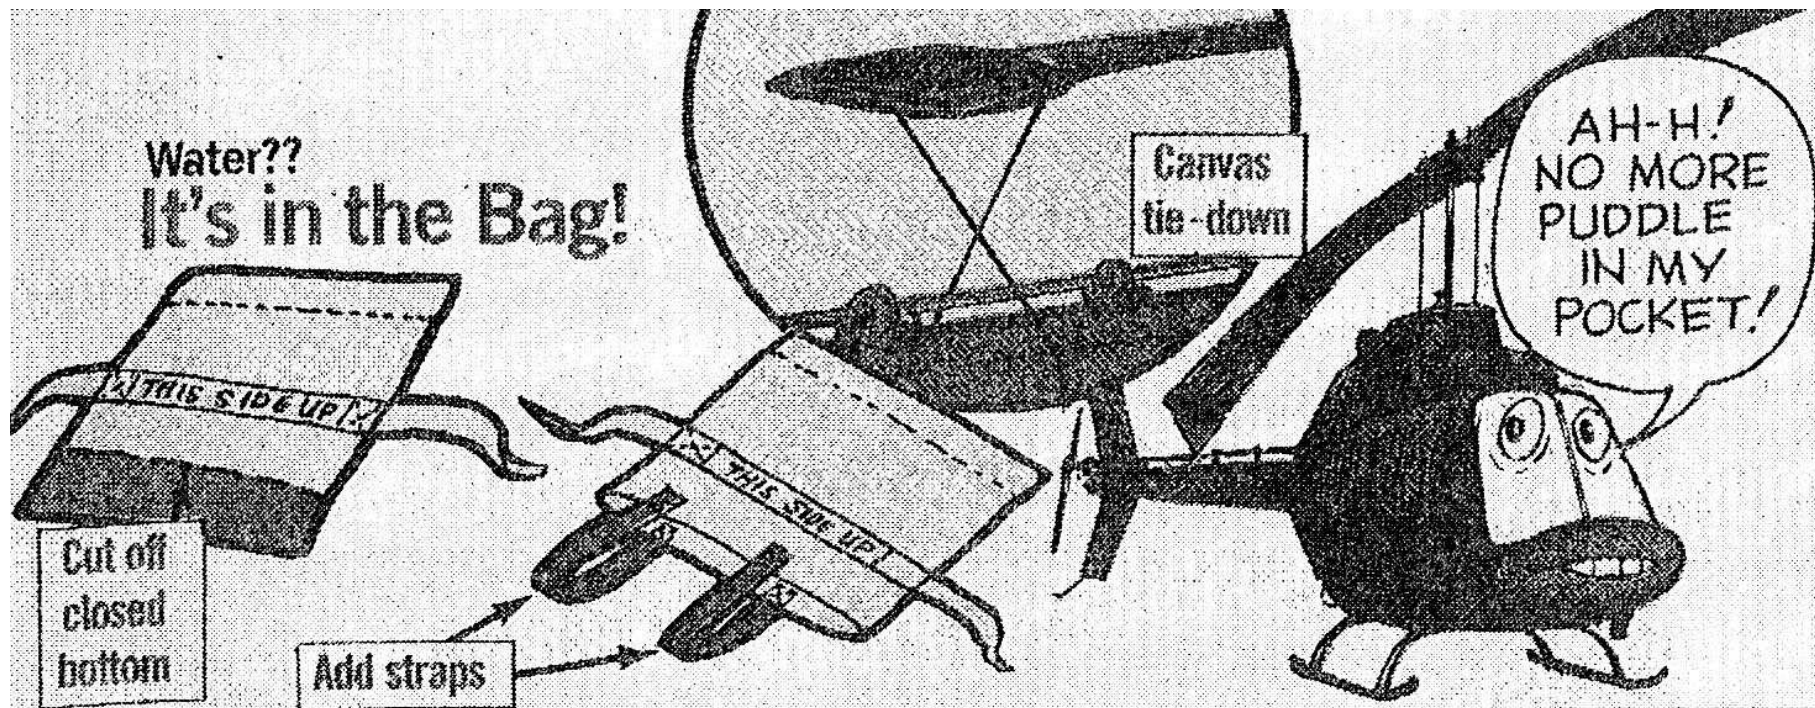
The trouble with the Kiowa main rotor tie-down is that it will collect water. And, if you're located in a salt water area, corrosion of the blade tip cap is a real possibility.

To head off that revoltin' development, check with your canvas repair shop.

Have 'em cut off about 3 inches at the closed end, to give you an open tie-down. The removed material is used to make 2 straps which are then sewed on the end of the tie-down to hold it on the blade.

That'll give you plenty of drainage.
