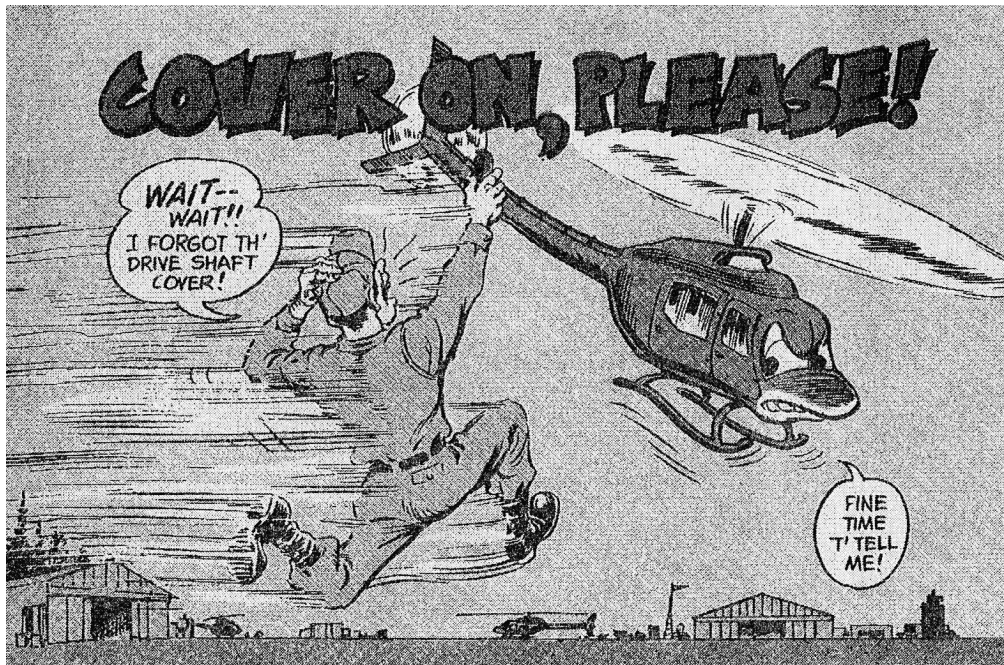
Take the drive shaft cover on the Kiowa (OH-58A). Sure, you only have about $\frac{1}{8}$ -in clearance between the cover and shaft. And a dent in the cover could chafe the shaft, meaning big trouble.

Never remove the cover permanently, tho, because it's part of the firewall. The airflow around the shaft is restricted by the cover. This prevents flames from spreading from the engine compartment to the transmission area in the event of a fire.

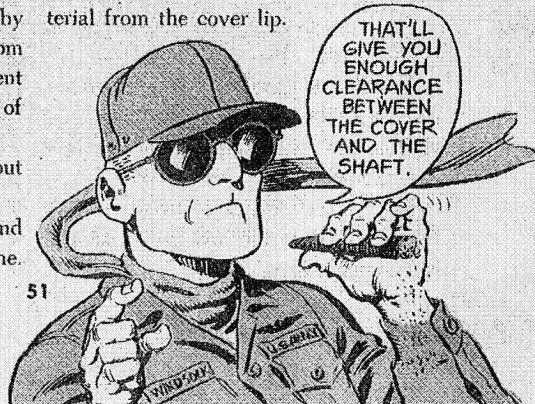
Trim off no more than 0.26 inch of material from the cover lip.

So, if the 2-piece cover is damaged and is too close to the shaft ask for a new one.

When you've made all the positioning adjustments possible and the cover still doesn't give you enough clearance try this for size:
