Gearbox Contamination?

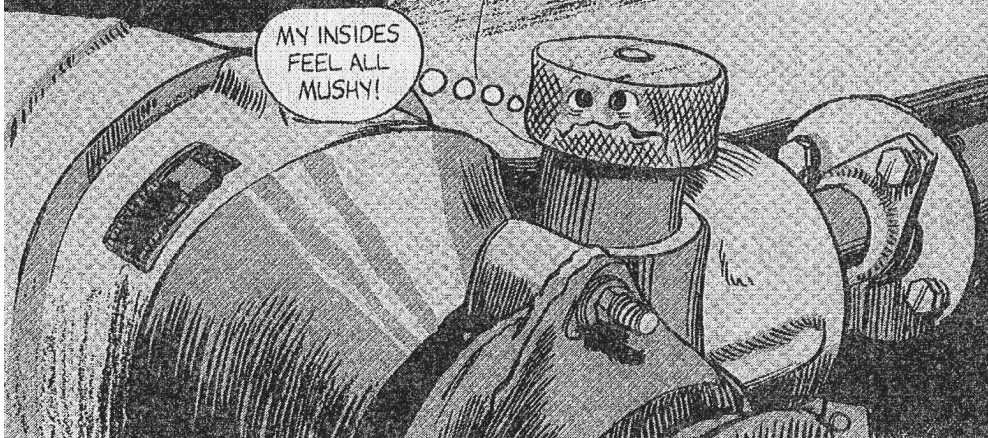
MY INSIDES
FEEL ALL
MUSHY!

The oil in your bird's tail rotor gearbox is constantly being attacked, both from within and from without.

Moisture in the air contaminates oil. It gets through the filler cap or through seals. So always be on guard. Eyeball the sight glass during every pre-flight inspection.

If you see any water bubbles; or if the oil has a dirty, milky appearance, drain and flush the gearbox. Refill the gearbox like it says in your bird's maintenance manual.
