On the Level . . .

New Seal Needed!

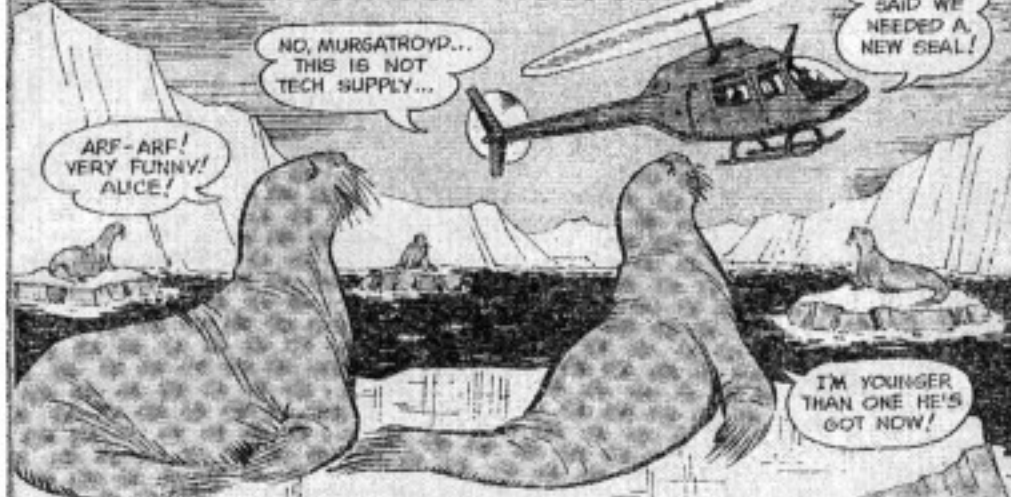
Engine oil level up?

Transmission oil level down?

There's a seal, P/N 6854086, on the engine power takeoff shaft that is not doing the job. When it's shot, transmission oil leaks into the engine accessory gear case. From there it's pumped into the engine oil tank.

To solve the problem, in the area of the freewheeling unit, you need the new double lip seal, NSN 5330-00-185-0341, in place of the old single lip seal.

Before installation, coat the recess in the seals—and the housing—with grease, MIL-G-25537. Insert the seals with the metal flange facing outward.
