ADDENDUM TO H-58-10-AMAM-11

COLLECTIVE FRICTION CLAMP

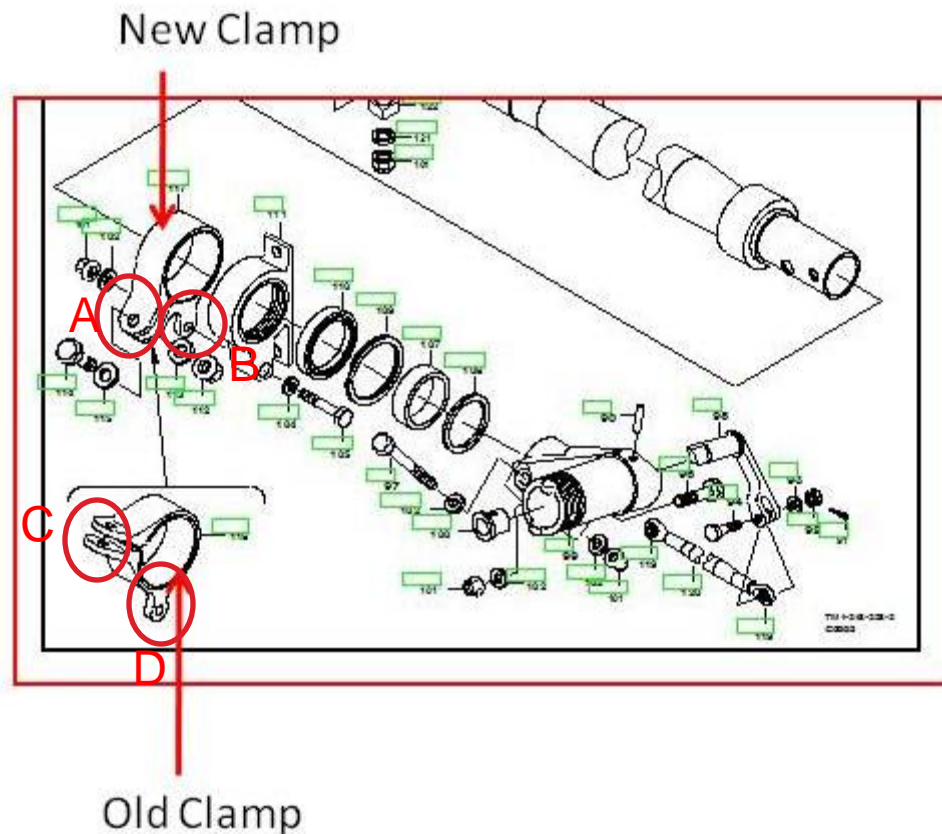
Note on the correct Clamp there is only about 45 degrees between the clamping bolt (inset A) and the mounting bolt (inset B).

On the old Clamp, there is approximately 90+ degrees between the clamping bolt (inset C) and the mounting bolt (inset D).
