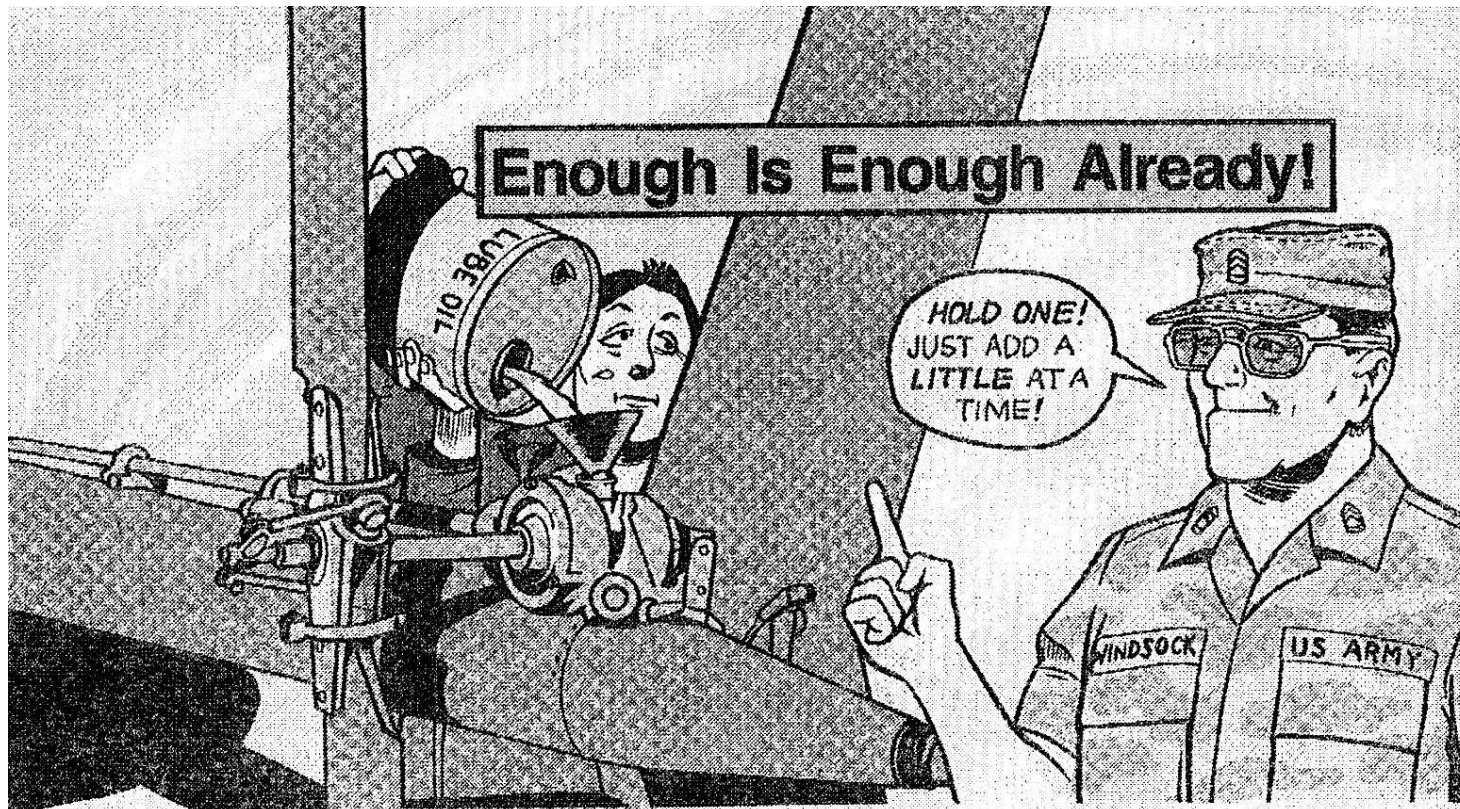
More is not better when it comes to lubricating the OH-58A/C tail rotor gearbox. Overfilling causes oil leakage. Then tail rotor trunnion bearings suffer. They wear faster and have to be replaced sooner.

So, Kiowa mechs, eyeball the gearbox sight gage. Add just the right amount of oil. Add a little at a time and let the level stabilize. Add a little more, if needed, to get the right indication on the sight glass.

That's 1/8 inch above the oil level line with standard gear. When high gear or floats are installed, the oil level should be even with the line.
