Never flex the OH-58A main rotor blade by grabbing the tip cap, Kiowa mechs. That kind of treatment will crack the facing compound.

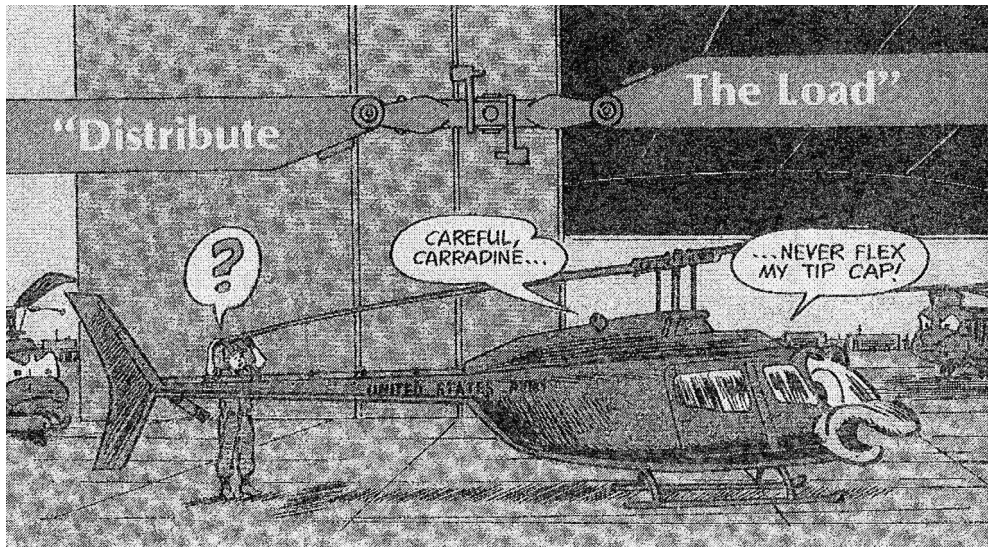
A surface crack in the compound—beginning about 4 inches aft of the spar and extending toward the trailing edge—is no cause for condemning the blade. There is no structural damage. Only the compound is affected so your buddies at support can make repairs in the prop and rotor shop.

You won't be faced with a grounded bird, tho, if you simply insert the blade tie-down over the end of the blade.
