Dear Editor,

TM 55-1520-228-20 (Oct 72), para 7-6, lists a leakage limit of 1 drop per minute (in a static condition) at the aft bearing cap of the free-wheeling unit on our Kiowa.

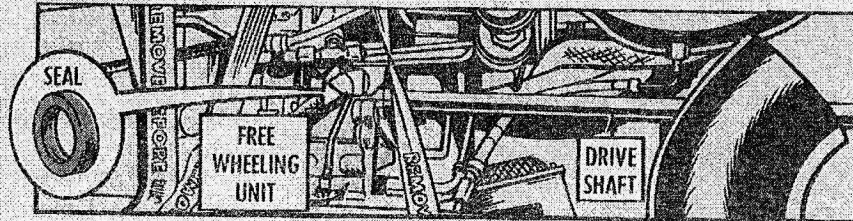
So, if you have a leak, the bird normally goes to support for replacement of a shot rear seal. That means grounding the bird for extended maintenance. Seal replacement is a complicated deal, including pressing out the old seal.

No more! Not with this handy impact puller we had made up in our shop.

All we do is take off the first section of the tail rotor drive shaft. Then, we insert the puller and use the impact part of the puller to remove the seal . . . no sweat.
