Supplement to H-58-09-MIM-006
Approved Change to TM 1-1520-248-23 Requiring NDI of Tail Rotor Gearbox Support

DA Form 2028 DCN 09A01762, Web Reference Number 090430120

Make the following Changes to TM 1-1520-266-23

TAIL ROTOR GEARBOX SUPPORT ASSEMBLY (OH-58D) (ET).

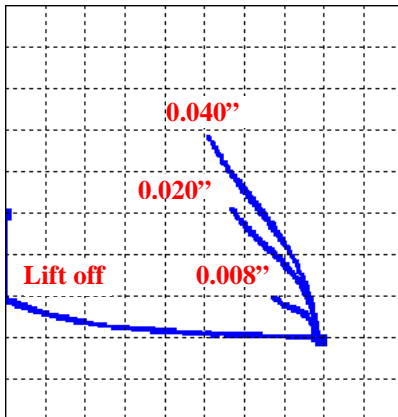
Figure 2A

1. Place the probe on a bare section of the test block and press NULL.
2. Utilize the ANGLE function to achieve horizontal lift-off. Reference Figure 2A.
3. Set up a 5 division vertical response from the 0.040” EDM notch on test block.
4. Place a .002" non-conductive shim over the 0.040” EDM on the test block and slide the probe over the notch.
5. Repeat step 4 utilizing a .005" and a .010" shim. Reference Figure 2B.
6. Place the probe on the material to be tested, note the horizontal deflection. Reference Figure 2C.
7. Lift-off may be slightly different due to the conductivity differences between the test block and the material being tested.
8. Non-conductive coatings less than .003" do not require lift-off compensation. If the coating is greater than .003" utilize the appropriate non-conductive shim during set up below.
