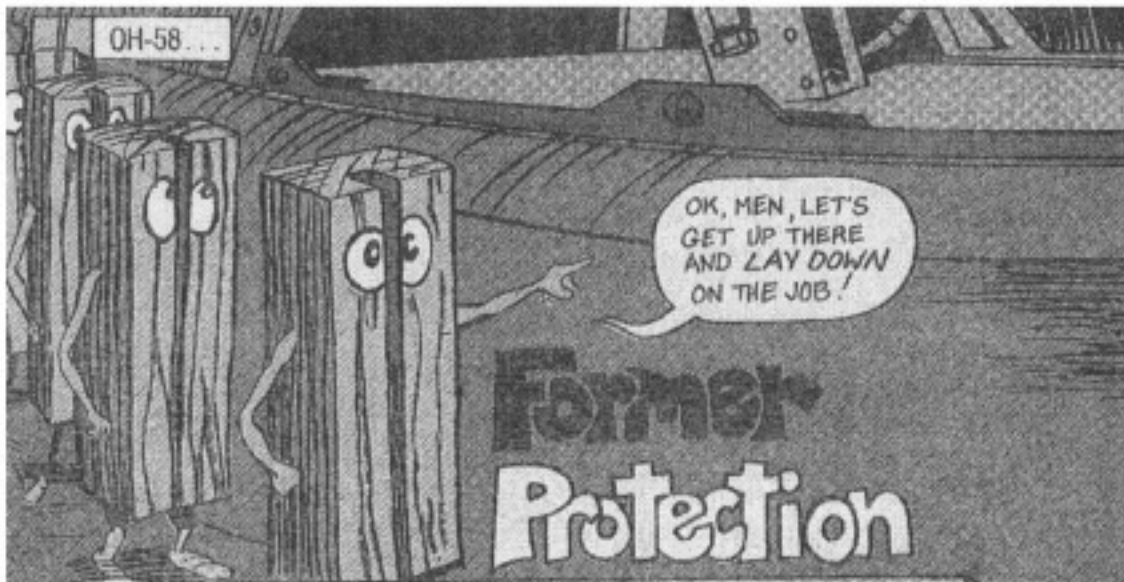
Any time the forward transmission cowling was removed on our OH-58's for maintenance or inspections, the formers were damaged by mechanics and inspectors stepping on them.

To solve the problem, I cut two 6-ft long 2x4's into 12-in sections and routed a narrow groove into one side of each section. The grooves are 1/4-in wide and 1/2-in deep. After smoothing the corners, I painted each section red.

Now, when the forward cowling is removed for maintenance or inspections, we slip these red, grooved sections over the formers on the cabin roof before climbing up top. We've eliminated about 90 percent of the repair time and maintenance cost for damaged formers. Our maintenance officer has included the fix in our unit's maintenance SOP.
