Driveshaft Cover Fix

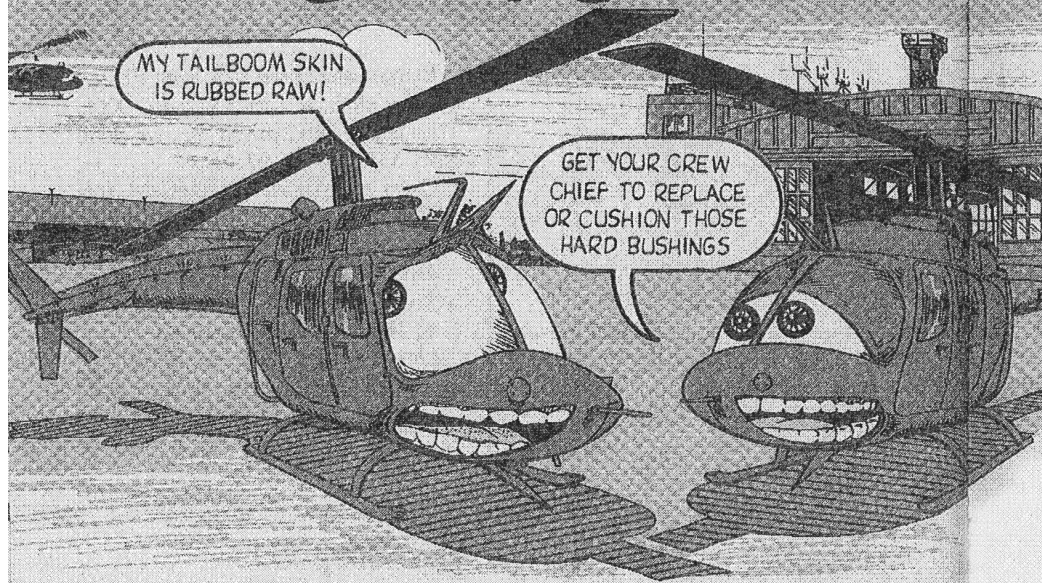
The nylon bushings that cushion the edge of your Kiowa's driveshaft cover can wear thru the paint on the tailboom's skin, creating a rust and corrosion problem.

When MWO 55-1520-228-50-25 is applied to your bird, it'll solve the problem because nylon pads will be installed along the tailboom where the bushings make contact.

Replace the hard nylon bushings with pieces of 3/16-in ID rubber surgical tubing, NSN 4720-00-141-9080.

Use an art knife or razor blade to cut the tubing into 1½- to 2-in lengths. Slit the pieces lengthwise. Use adhesive, NSN 8030-00-753-4596, to glue them in place on the driveshaft cover.

The rubber stays soft and won't wear into the tailboom skin like the nylon bushings do.
