# Slip Solution

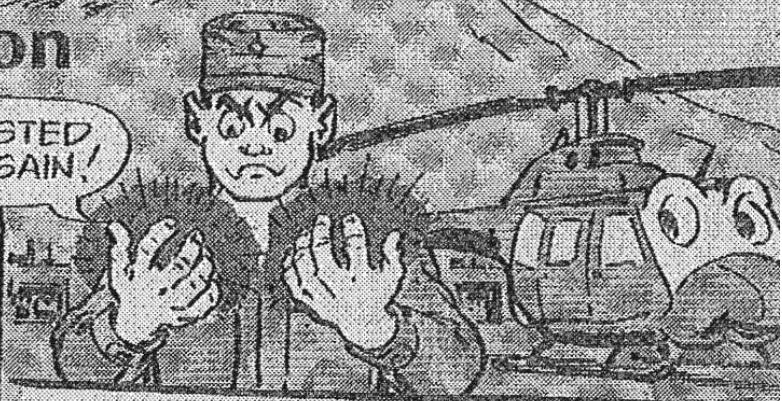
Removing and installing the OH-58 transmission main input pinion adapter gives you bruised knuckles, damaged honeycomb panels and component damage. Special tool T101555 slips off because of the 150-166 lb-ft torque on the nut.

No more! We solved the problem by bolting the tool to the adapter.

Just drill a 1/4-in hole in the special tool, using the adapter as a pattern.

Use an AN4-7 bolt and nut to hold the tool in the adapter...no more slips!
