Kiowa Seat Fix

We have come up with a simple fix for preventing damage to passenger seat panels on OH-58's.

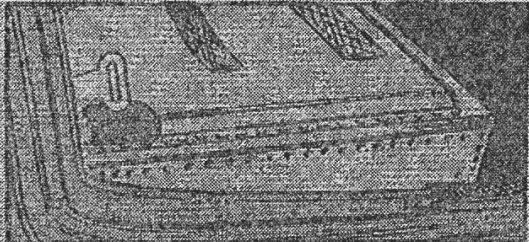
The passenger seat belt yokes used to dent and even puncture the honeycomb panels. But no more!

We installed a doubler in both aft corners of the seat panel where the belt yokes hang against the seat.

Make the doubler from 2024-T3 aluminum, NSN 9535-00-084-4396, and fasten it with adhesive, NSN 3049-00-016-8662. For best results let the adhesive dry for 24 hours.
