GEAR BOX FLUSH?

COMES THE TIME WHEN YOU HAVE TO REPLACE THE KIOWA TAIL-ROTOR GEAR BOX, FOCUS IN ON THE ORGANIZATIONAL MAINTENANCE PUB.

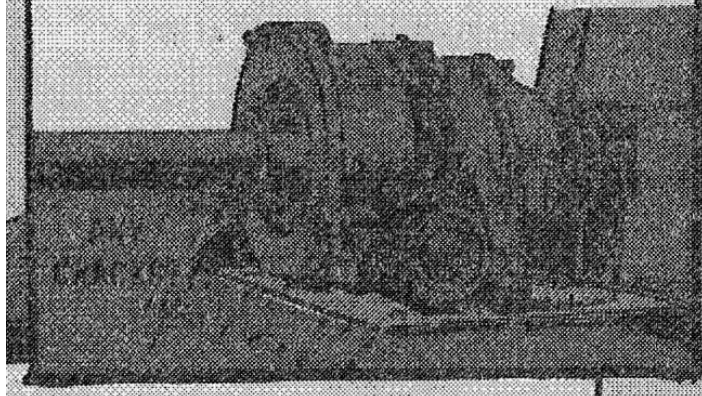
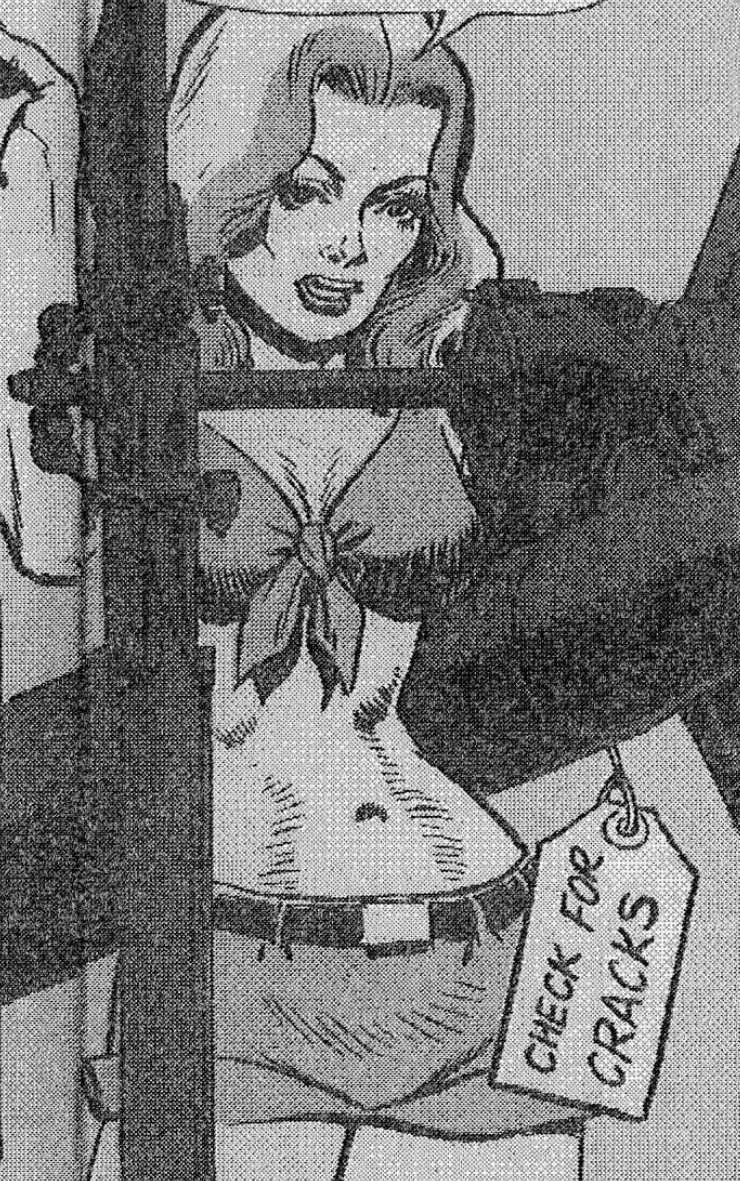
When you place the gear box in position, eye the mounting area on the tail boom to make sure that the aft 2 washers and forward aluminum angle are bonded in place. If any of those parts are missing you won't be able to mount the gear box on a level surface. The result will be cracks in the tail boom mounting surface.

CHECK FOR CRACKS

So, fabricate a 1/2-in plate according to the directions in TM 55-1520-228-20 (Oct 70).
